BANK STABILIZATION ON MOORE'S CREEK

5th Street Station, Charlottesville, VA

Phase 1 and 2 Construction

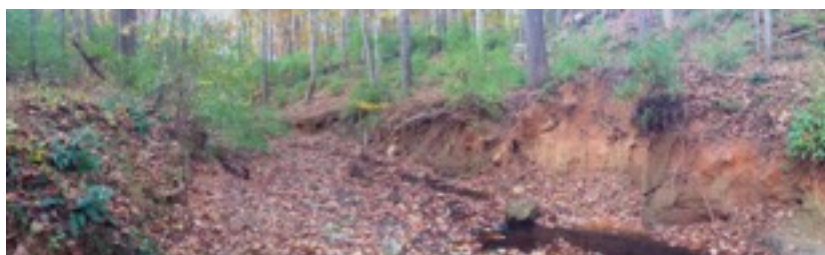
Areas along Moore's Creek and a tributary were in need of stabilization. The closed landfill had been compromised and continued to release trash into the stream. A sanitary trunk sewer had been exposed along the bank. Areas of sloughing banks threatened a recreation trail. This study is an analysis of the effectiveness of measures selected for stabilizing the various areas.

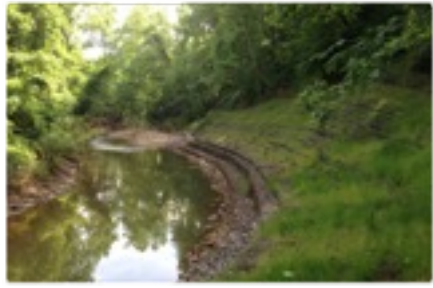
Gabions and Filtrexx Living Wall™

Access issues aside, the construction of the Gabions and Living Wall went fairly quickly. The key to the success was establishing a suitable starting point. Working in the dry allowed the contractor to place stone to create a flat starting point for gabion construction. Much like a building, once the foundation is flat and stable, the construction can progress quickly.

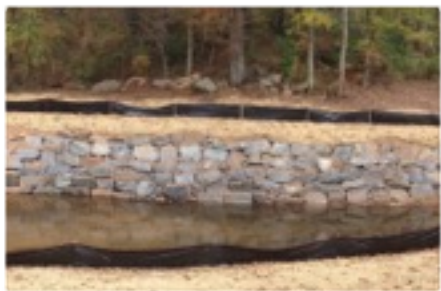
Dry Stack Wall

This measure was only permissible as an emergency situation arising from the exposed sanitary trunk sewer in the eroding bank. Similar to the Living Wall construction, the key was establishing a suitable base. The contractor was not able to divert the creek, so, working under a few feet of water, it was difficult to see the starting point for the wall. Once the first layer was set, however, the construction was completed in about 2 months.
